**UNITED STATES
TENNESSEE VALLEY AUTHORITY**

THE WHEELER PROJECT

**A Comprehensive Report on the Planning, Design,
Construction, and Initial Operations
of the Wheeler Project**

TECHNICAL REPORT No. 2

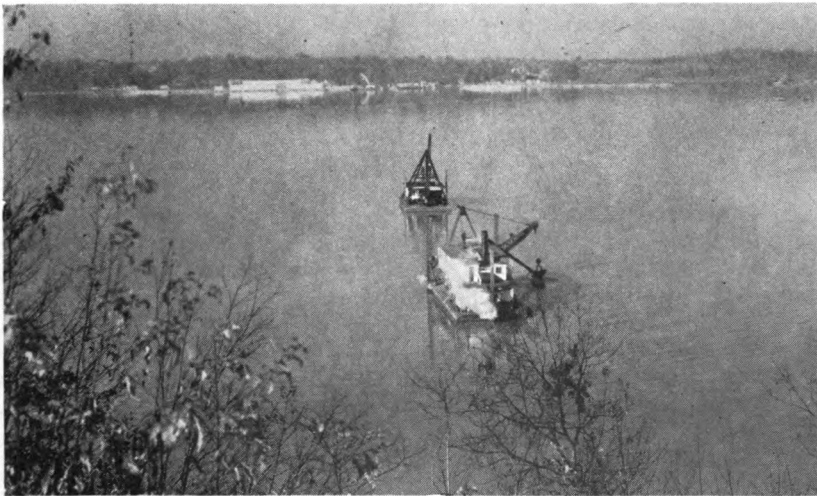
FIGURE 3.—*Wheeler site before the start of TVA construction.*

(Note lock under construction in left background)

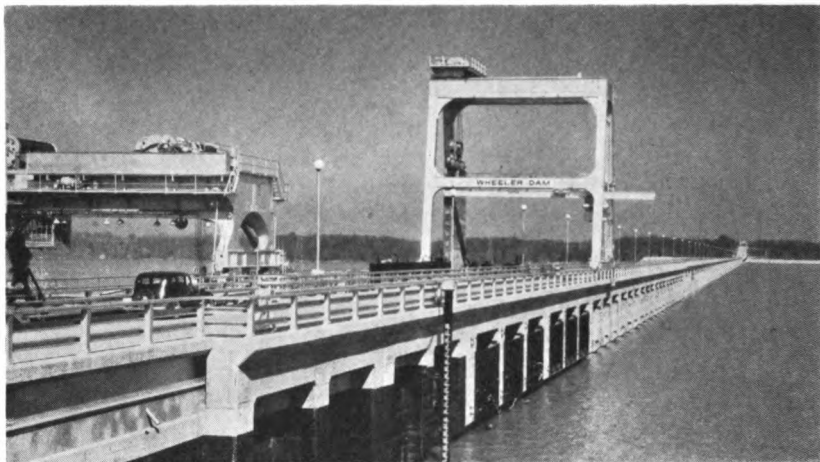
FIGURE 35.—85-ton gantry crane for intake gates.

when loaded. Sanders, electrically operated from the operator's cage, are provided for sanding the gantry rails.

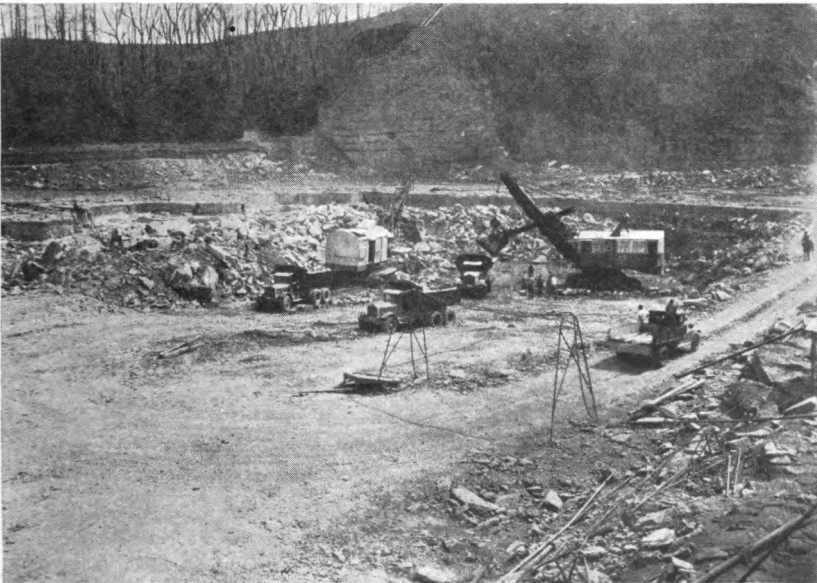
FIGURE 70.—Shovels for foundation excavation.

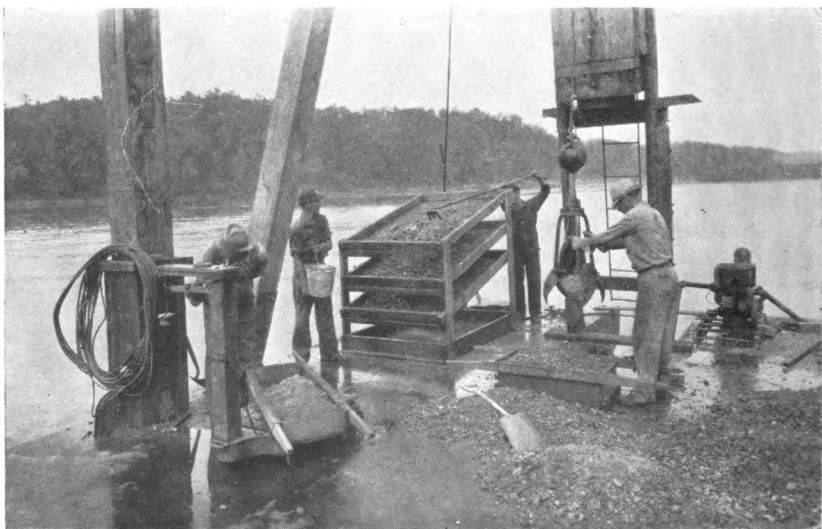
FIGURE 78.—Testing equipment for gravel survey.

Surveys made by the United States Army Engineers in the section of the river between Sheffield and Riverton indicated that sufficient sand and gravel for the construction of the dam could be obtained in a 4-mile stretch immediately below Seven Mile Island. This was located within an average towing distance of about 30 miles from Wheeler Dam. Bids for supplying the aggregate were requested, and the Cumberland River Sand Co. was low bidder at a price of \$0.895 per ton delivered at the dam site. It was considered advisable to have this work done by private contract at that price rather than secure equipment and do the work by force account. Accordingly, a con-

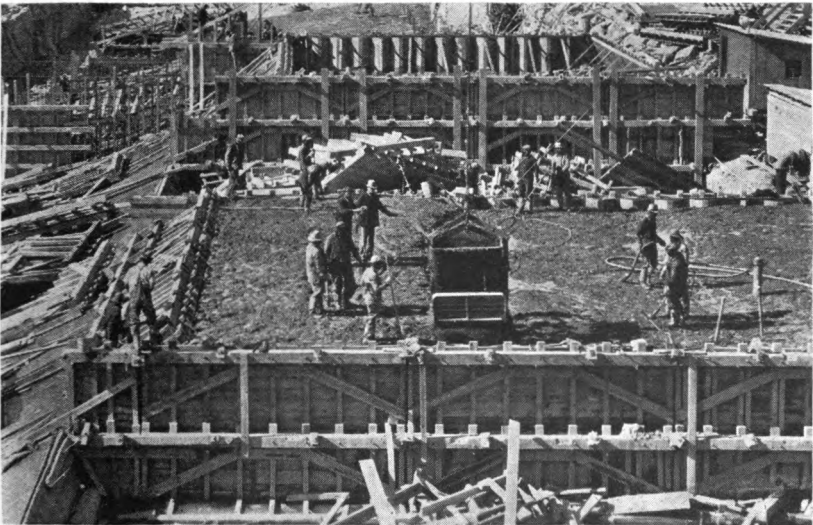
FIGURE 94.—Placing mass concrete.

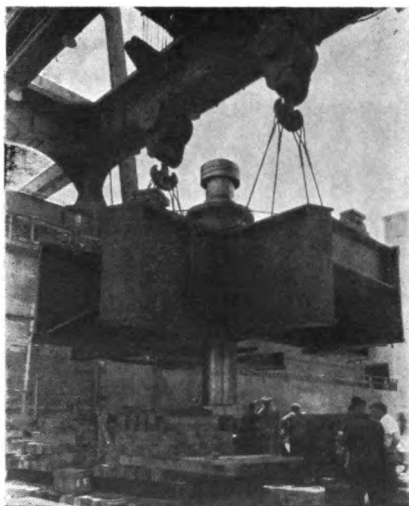
FIGURE 107.—Lower bracket and shaft assembly.

While the rotor was being assembled in the assembly bay, the lower bearing bracket was being assembled on the deck at elevation 540.3.²¹ When the bracket had been completed, the shaft was placed in the bracket but was supported by separate cribbing on the deck to keep the weight of the shaft off the upper bearing plate. The upper and lower collars of the guide bearings, consisting of two sections each, were then set and all springs placed.

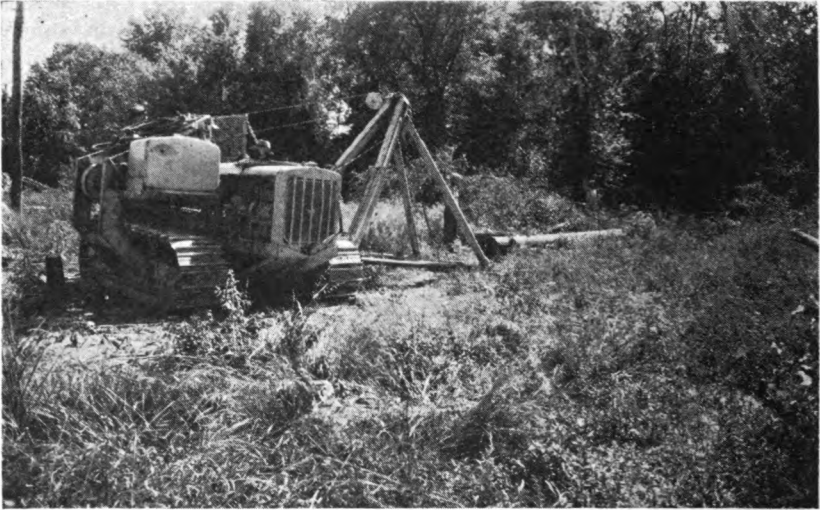
FIGURE 119.—Bank-pulling machine.

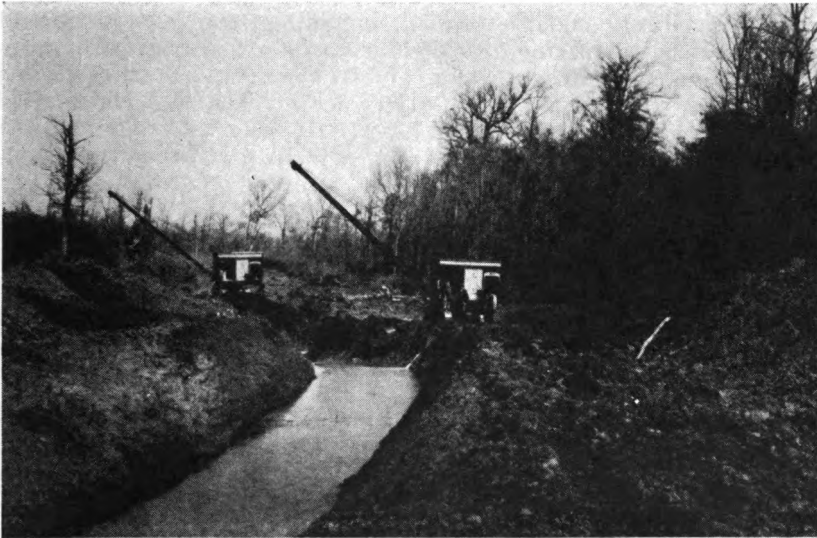
FIGURE 120.—*Light-weight draglines.*

Clearing was hampered by the presence of many swamps. In addition, numerous depressions or pools existed near the pool level of the reservoir which would become stagnant ponds when the pool level dropped. It was found that drainage would be practical and economical in clearance work and would materially aid in the control of mosquito breeding and reduce malaria-control expense. Light-weight crawler draglines with $\frac{1}{2}$ -cubic-yard buckets were used for digging the ditches for draining these areas. When not needed for excavation work, they were also used for piling logs. In preparing these drainage canals, 117,000 cubic yards of earth were excavated to facilitate clearing, while 23,700 linear feet of lateral ditches were dynamited to promote drainage. (See figure 120.)

The two outstanding pieces of machinery used in the clearance work were the bank-pulling machines and the lightweight crawler draglines for draining swamps. These machines were selected after a thorough investigation of available equipment. (See fig. 119 and 120.) Power saws were investigated but were not used because it was felt they had not been developed sufficiently.

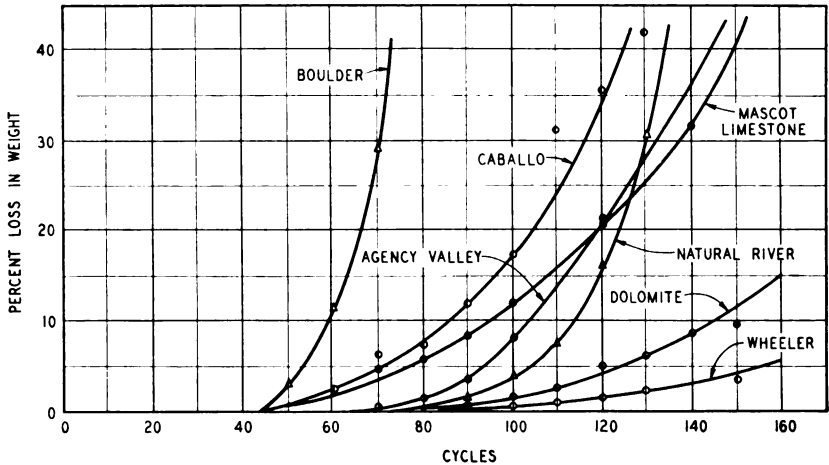
FIGURE 137.—Results of freezing and thawing tests on 3- by 6-inch cylinders showing percent loss in weight.
